Post-Disaster Safety Assessment Program (SAP)

Evaluator Training

December 2016

Safety Assessment Program Evaluator Student Manual

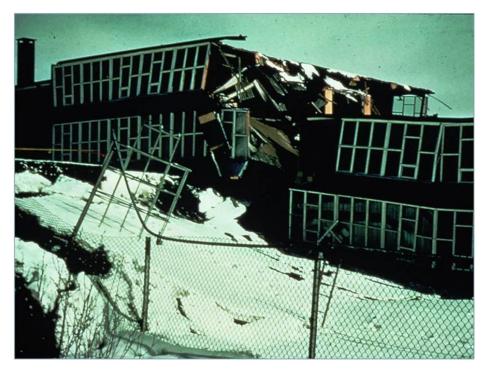
Figure 2-9 – Ground scarp through building

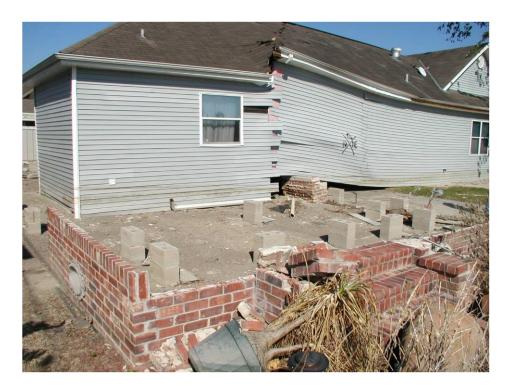
Figure 2-14 – Wood frame home floated off its foundation, 2005 Hurricane Katrina

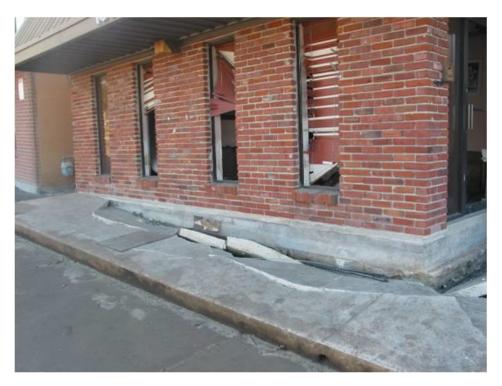
Figure 2-15 – Scouring under sidewalk, 2005 Hurricane Katrina

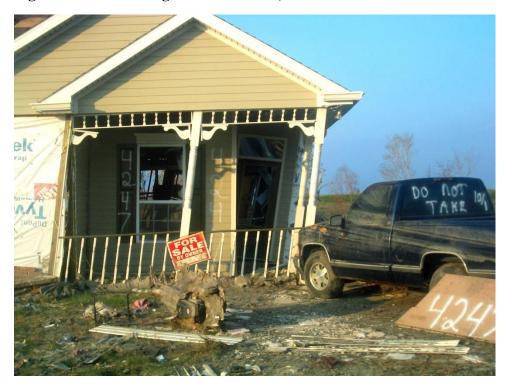
Figure 2-16 – Racking damage to wood frame building, 2005 Hurricane Katrina

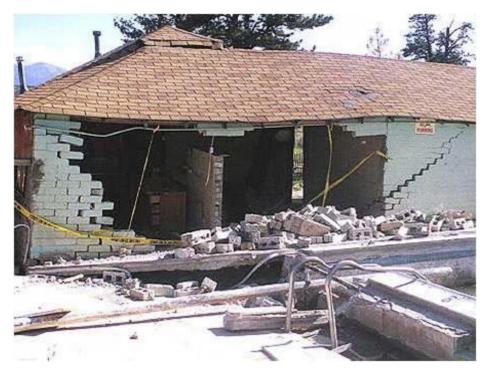
Figure 2-27 – Uplifted pool and damaged URM building, 1992 Big Bear Earthquake

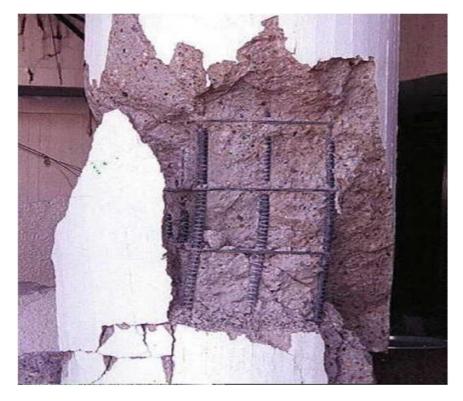
Figure 2-29 – Detail of damaged column showing P-delta effect

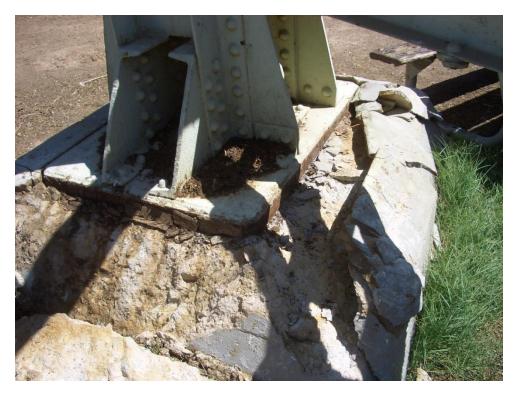
Figure 2-32 – Damage to water tower concrete footing

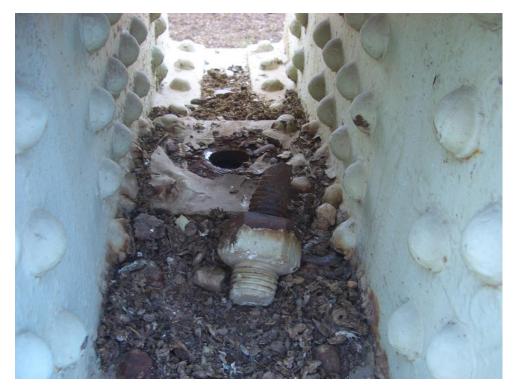
Figure 2-33 – Snapped bolt at footing of water tower

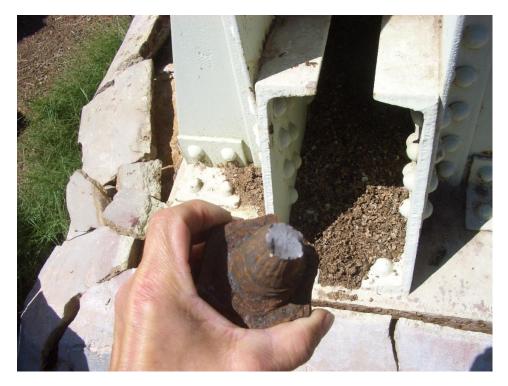
$\begin{tabular}{ll} Figure~2-34-Drawn~and~snapped~connector~at~footing~of~water~tower,~also~note~footing~damage \end{tabular}$

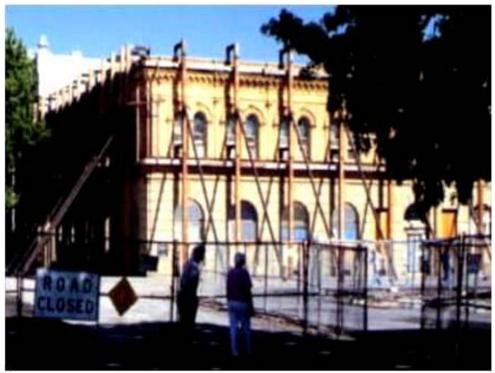
Figures 3-11 and 3-12 show a building that was badly damaged by the Loma Prieta earthquake. The floor and roof systems separated from the walls, and were a distinct collapse hazard. After considerable evaluation and discussion, a system was developed to save the historic character of

Figure 3-11 – Historic building, Santa Cruz, 1989 Loma Prieta Earthquake

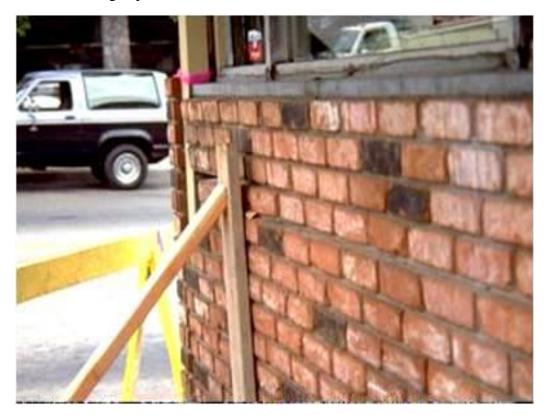
In Figure 3-14, the braces are too slender to support the wall. They were installed tight as well, indicated by the bowing in the braces. Even a moderate aftershock or wind would have the capacity to load these braces to the failure point. If a SAP evaluator finds a situation like this in the field, the collapse zone should be barricaded with barricade tape, tagged AREA UNSAFE, and the building department alerted about this hazard.

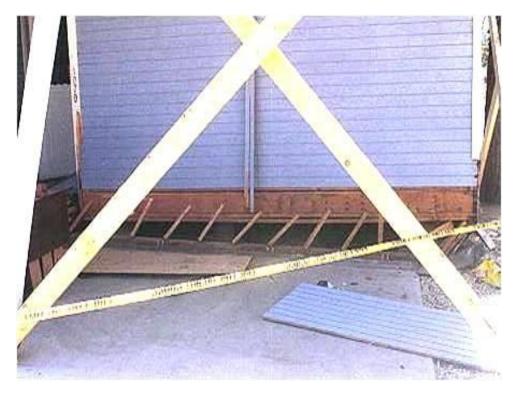
Figure 3-17 – House with cripple wall failure, 1992 Big Bear Earthquake

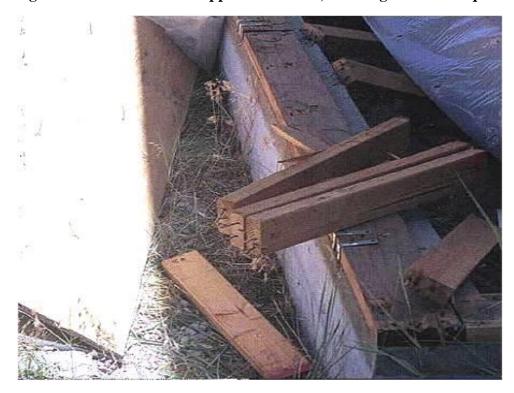
Figure 3-18 – Detail of failed cripple wall, 1992 Big Bear Earthquake

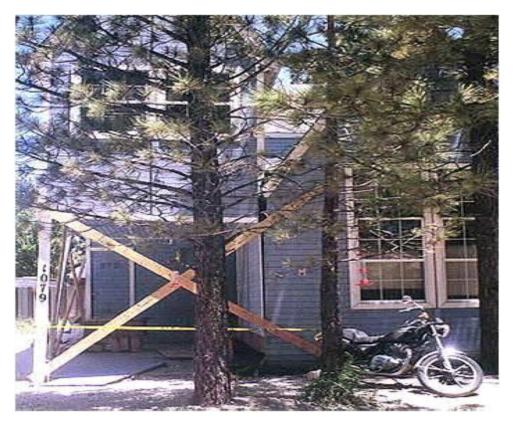
Figure 3-19 – Collapsed house with failing upper room, 1992 Big Bear Earthquake
